AFWAL-TR-82-2044

LOCAL LEADING EDGE DAMAGE FROM HARD PARTICLE AND SOFT
BODY IMPACTS (TASK IV B)

University of Dayton Research Institute
Dayton, Ohio 45215

Interim Report for Period 1 January 1979 - 1 December 1980

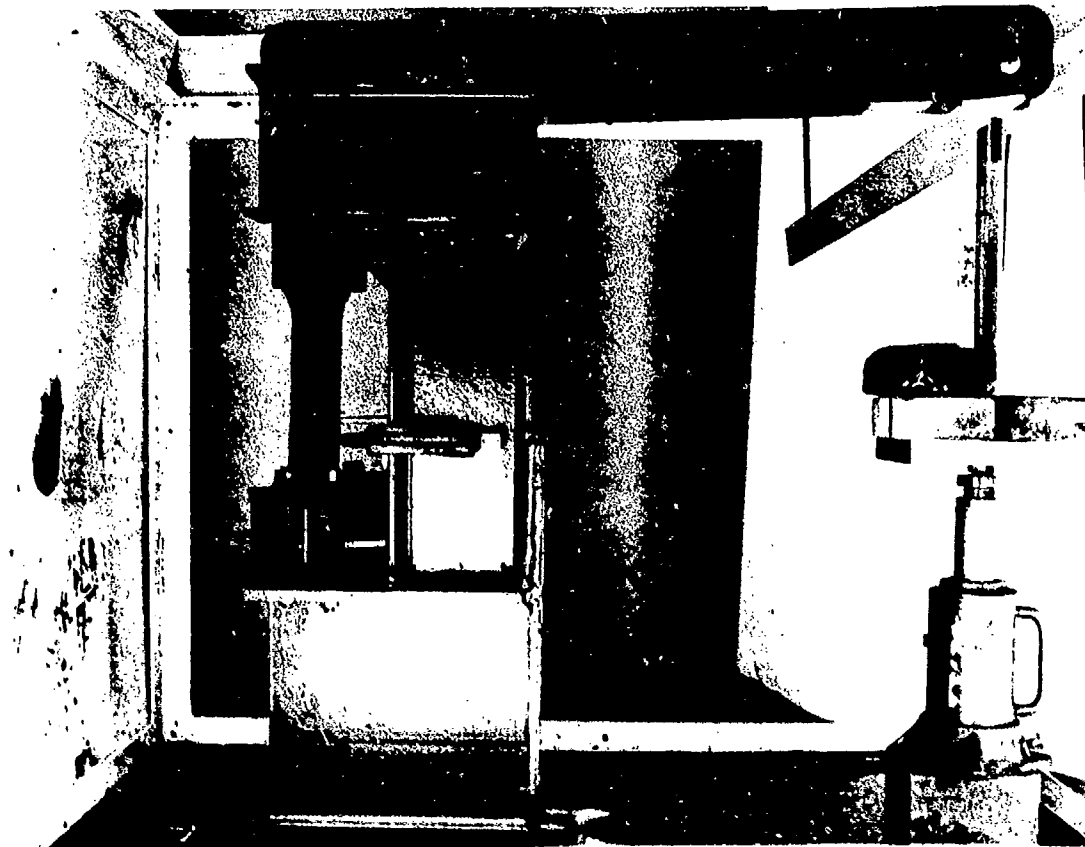
Figure 8. Apparatus Utilized to Preload Specimens.

The effects of preload (centrifugal loading in a blade) was investigated. The apparatus utilized to preload specimens is shown in Figure 8. It consisted of a beam supported by a structure such that a 30 to 1 moment arm exists. By attaching the specimen at one end of the beam and placing weight to the other end, the specimen could be loaded in tension. By knowing the moment arm and weights accurately, the amount of force applied to the specimen was calculated. The cross-sectional area of the specimen was known, therefore, the stress could be calculated in the preload testing for the specimens.

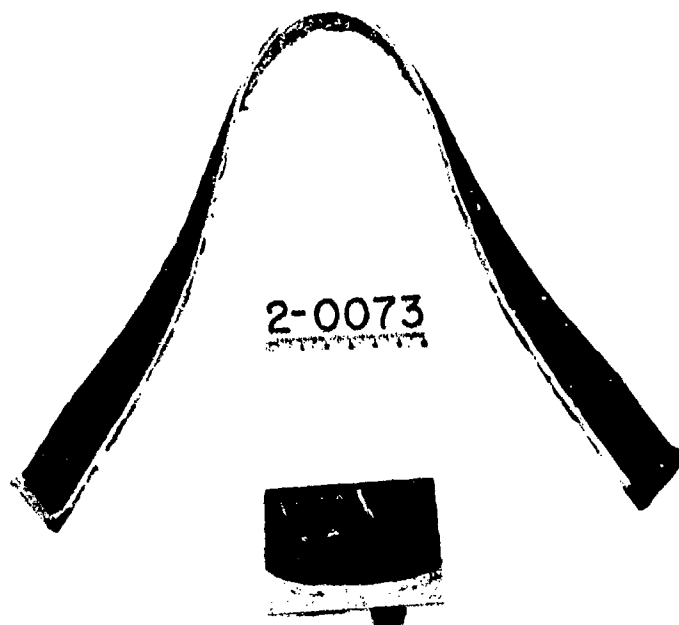
Figure 11. Extensive Bending Damage Mode at Impact Site.

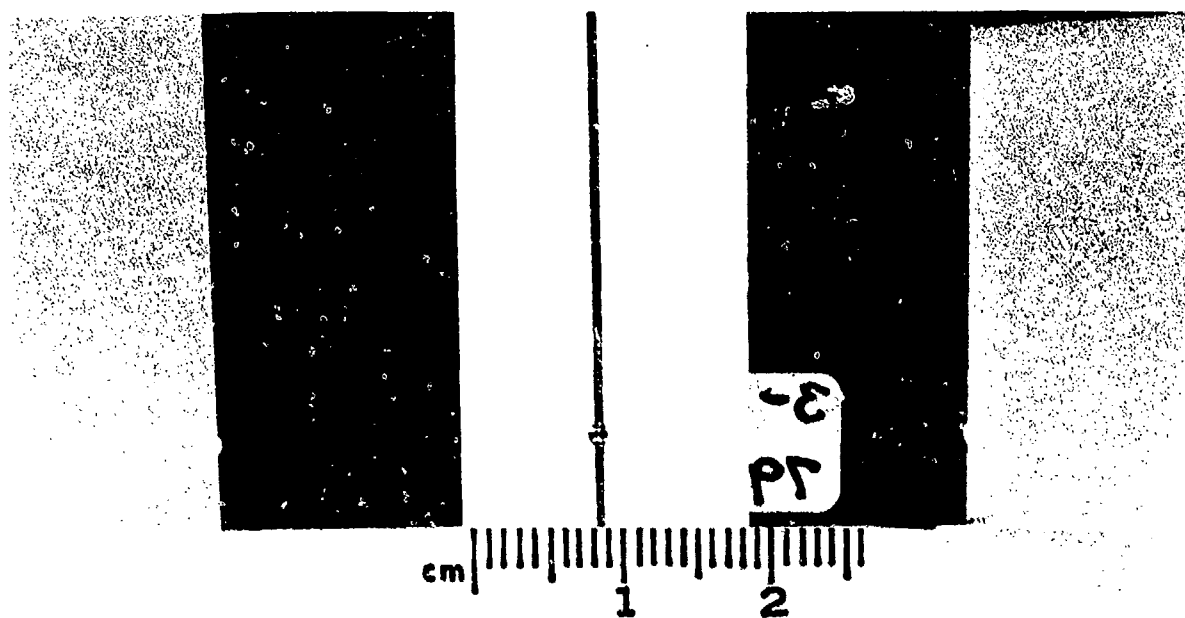
3-0116

Figure 22. Typical Damage Received on 0.61 mm L.E. Thickness Stainless Steel Specimens from 1.59 mm Projectile Impacts at 36.4°.

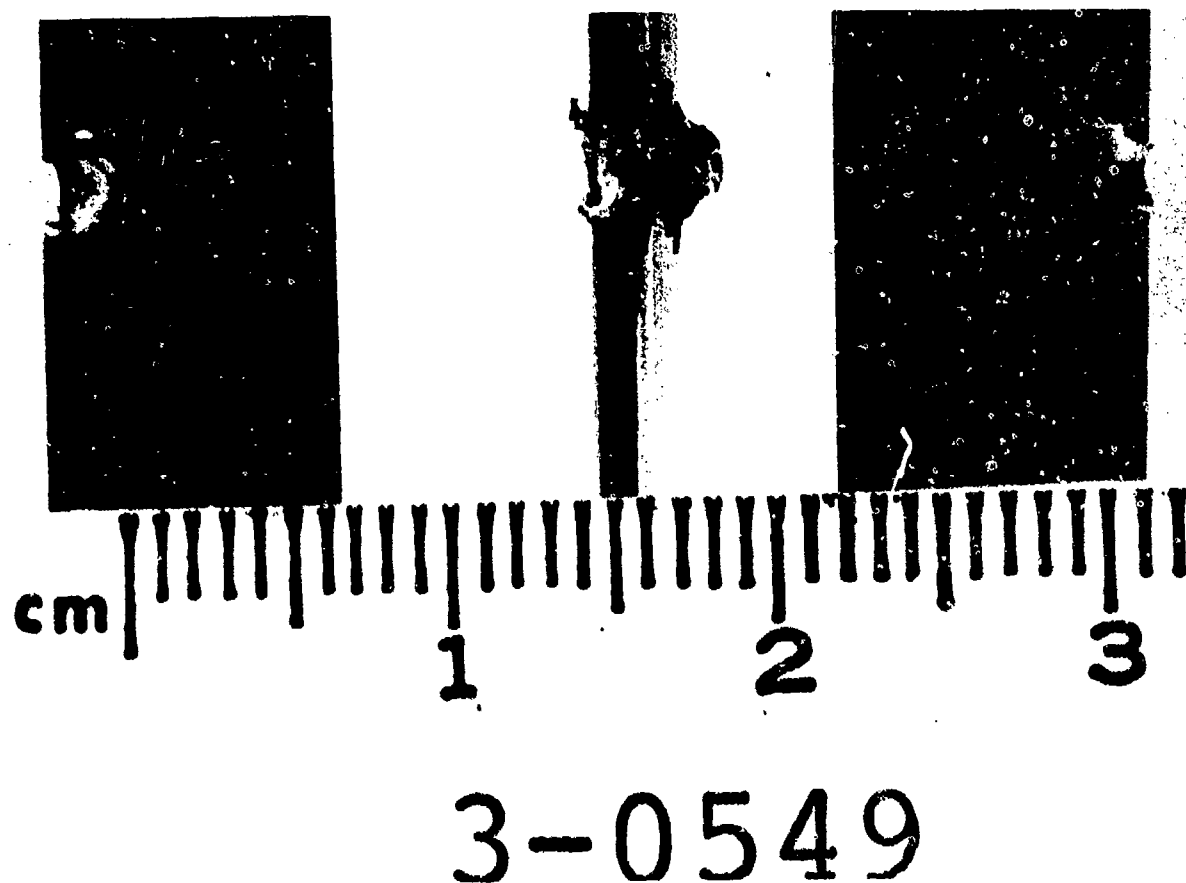
Figure 32. Typical Damage Received on Thick Leading Edge
Boron/Aluminum Specimens from 3.18 mm Projectile
Impacts at 18.9°.

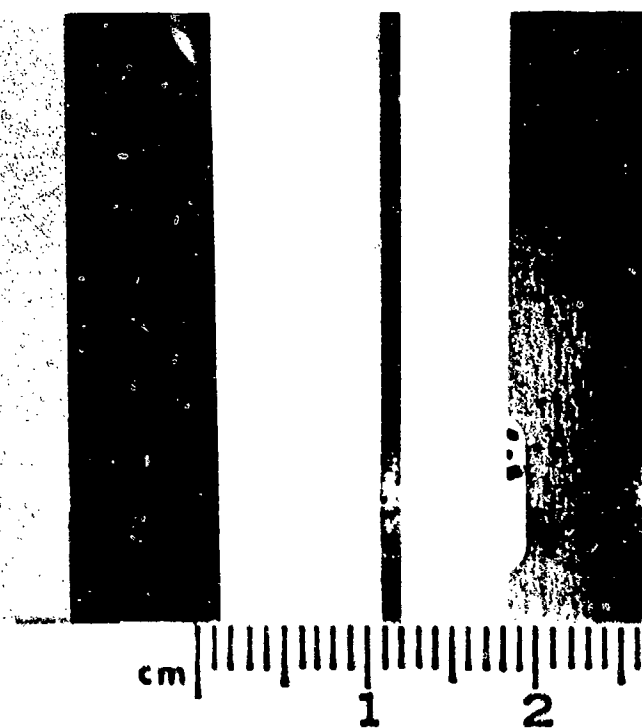
3-0073

Figure 34. Typical Damage Received on Stainless Steel Specimens from Pebble Impacts at 36.4° .

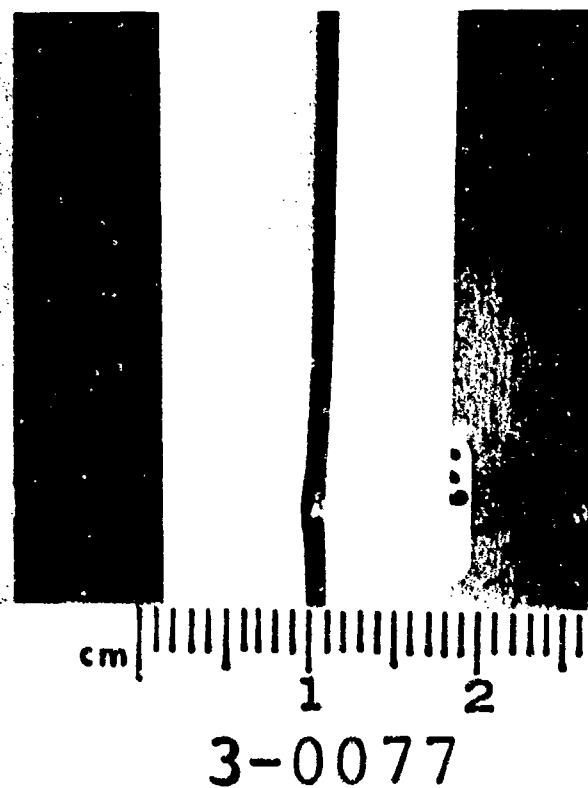
Figure 35. Typical Damage Received on Stainless Steel Specimens from Pebble Impacts at 51.1°.

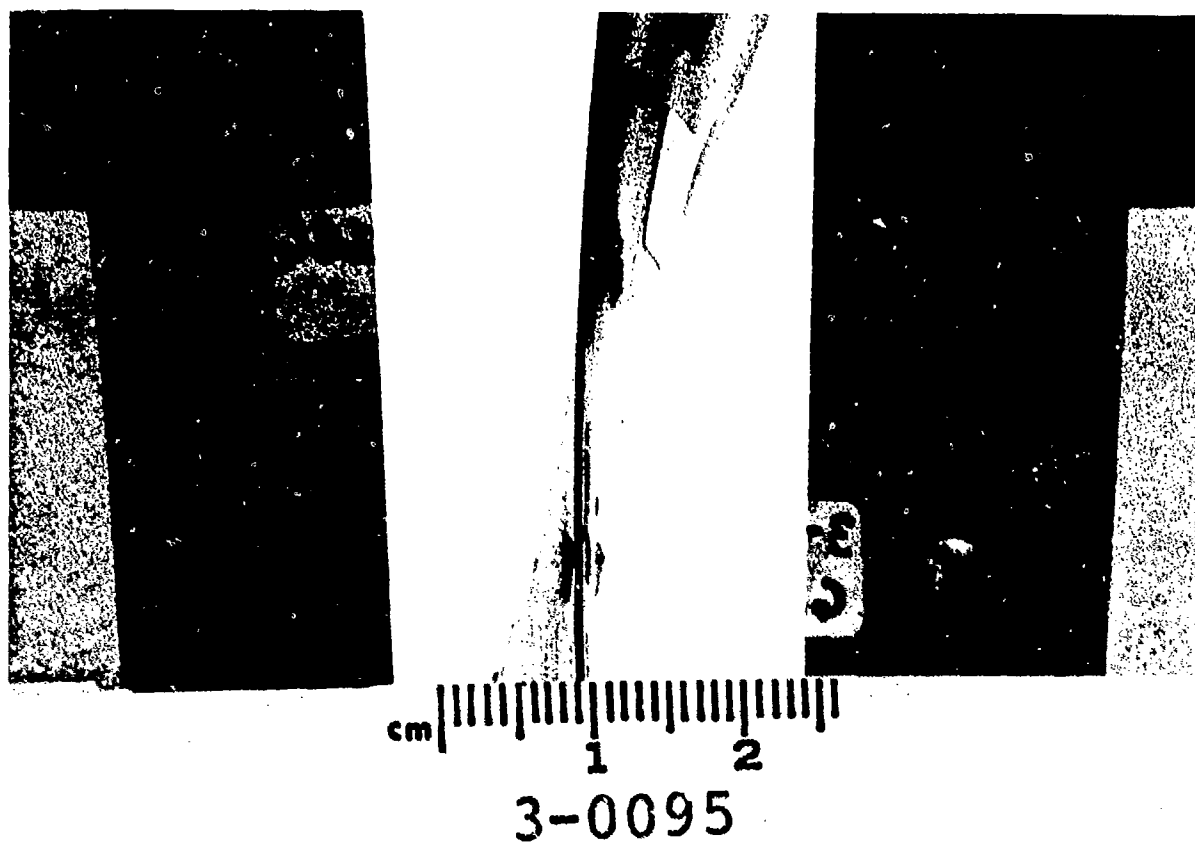
Figure 38. Typical Damage Received on APSI Blade from Pebble Impact at 187 m/s.

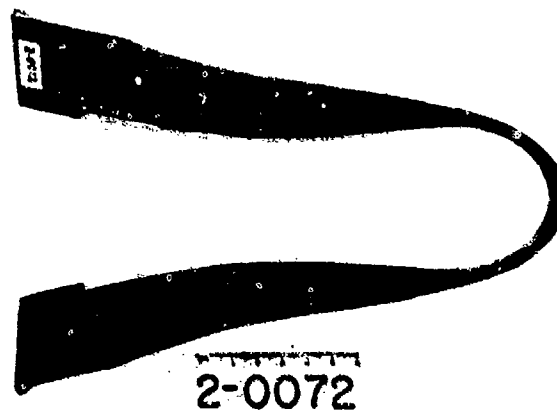
Figure 40. Typical Severe Bending Damage for 85 gram Bird Impact on 403 Stainless Steel Specimens.

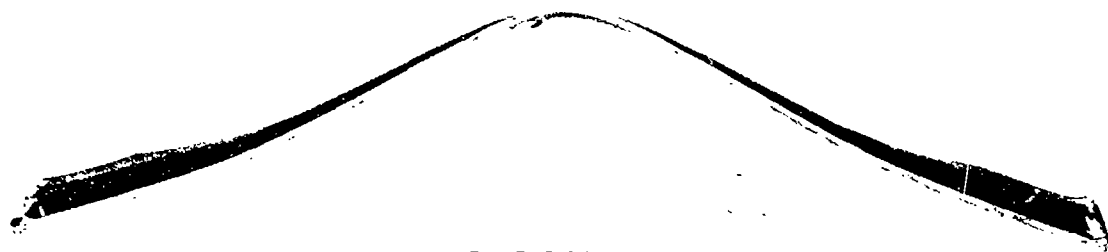
2-0074

Figure 42. Typical Measurable Damage on 403 Stainless Steel Specimens from 85 gram Bird Impact at 51.1°.
